## 3 CABIN FIRE SIMULATOR LAVATORY TESTS

(NASA-CR-160909) CABIN FIRE SIMULATOR LAVATORY TESTS Final Report, Jun. 1978 -Jun. 1980 (Douglas Aircraft Co., Inc.) 344 p HC A15/MF A01 CSCL 01C N81-16020

**\( CONTRACT NAS9-15591 \( \cdot MAY 1980 \)**

Final Report for Period of June 1978 — June 1980

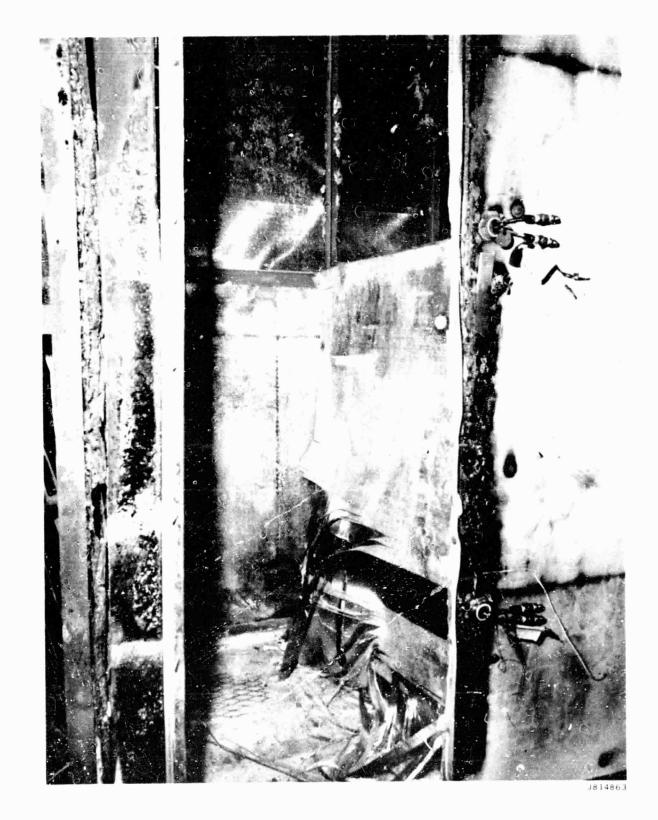
FIGURE 18. MODULE A INTERIOR POST-TEST

The interior of the lavatory, Figure 18, illustrates the general condition of all panels. Resin burnout was extensive; it was complete in the case of the washstand side and a major portion of the inner door surface.
